Debris/Ice/TPS Assessment And Integrated Photographic Analysis For Shuttle Mission STS-45

May 1992

Gregory N. Katnik
NASA/Kennedy Space Center

March 24, 1992

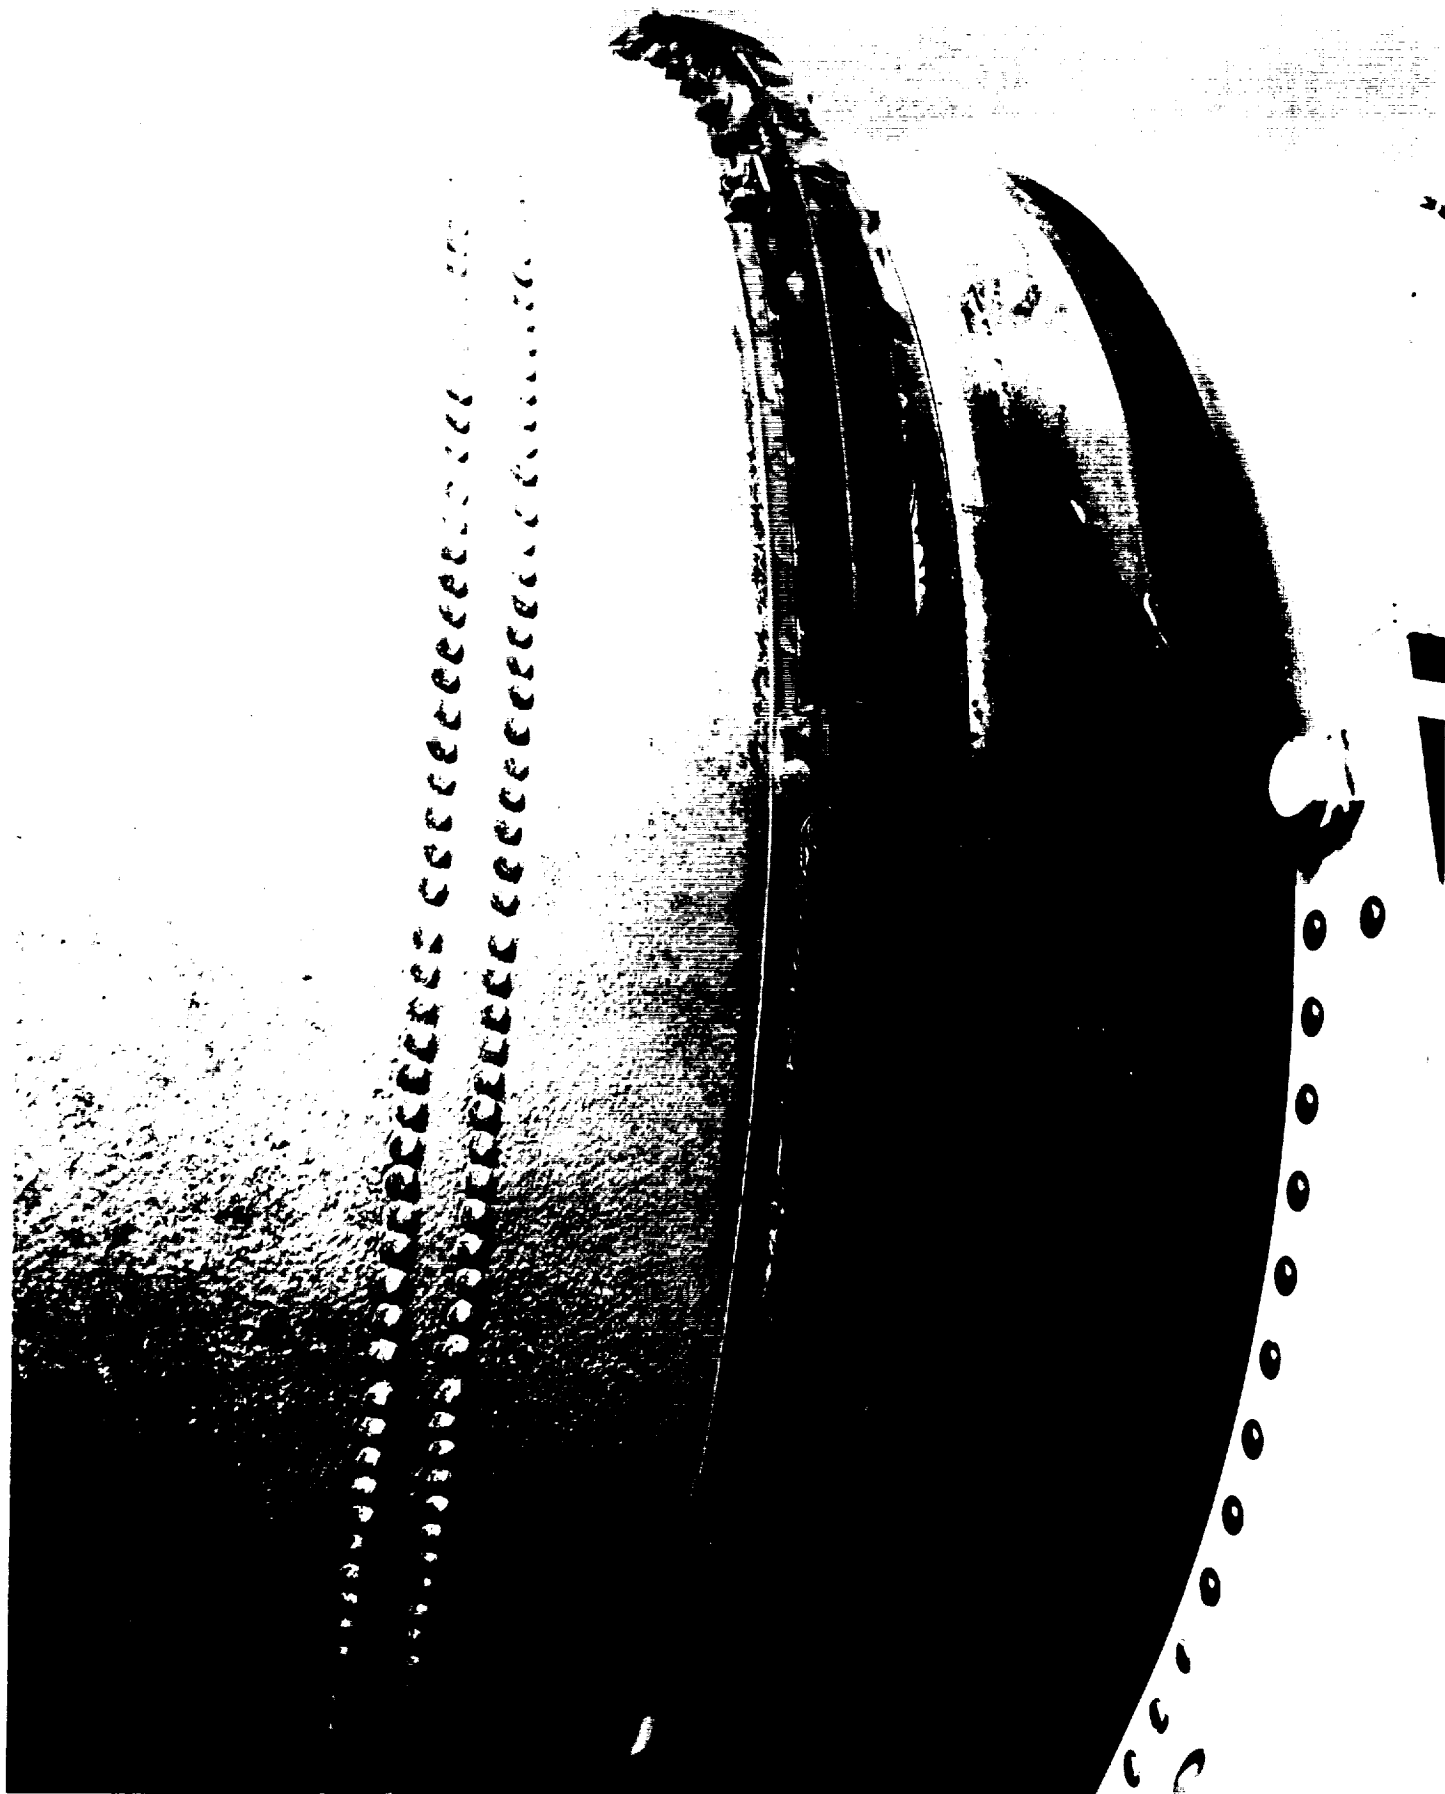
The phenolic material on the kick ring had delaminated. Several K5NA protective domes were lost from bolt heads on the aft side prior to water impact (sooted substrate).

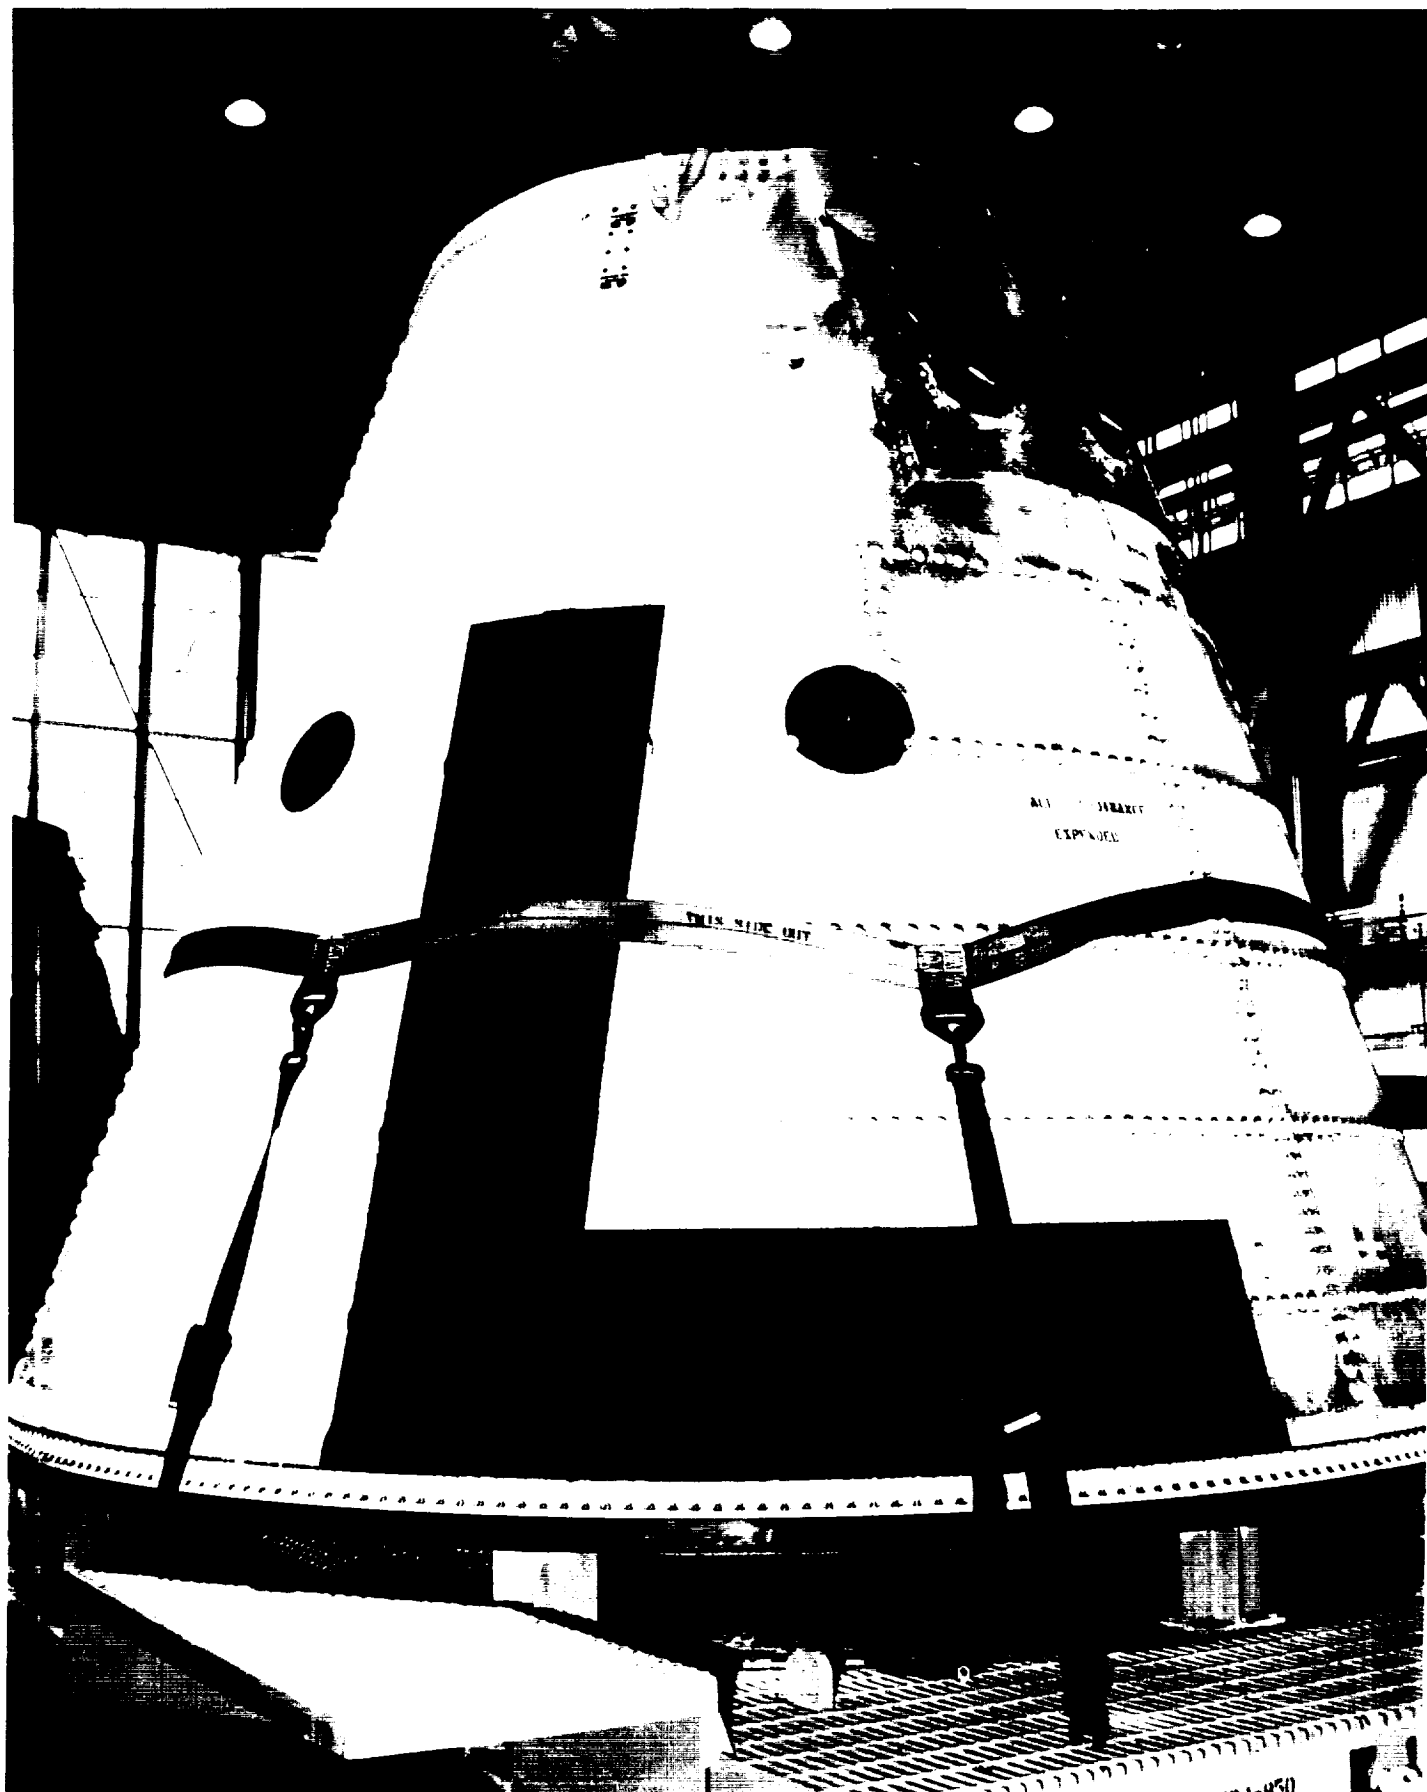
The LH frustum was missing no TPS but had 12 MSA-2 debonds over fasteners. The largest debond measured 3"x2" and was located between the -Y and +Z axes near the 381 ring frame.

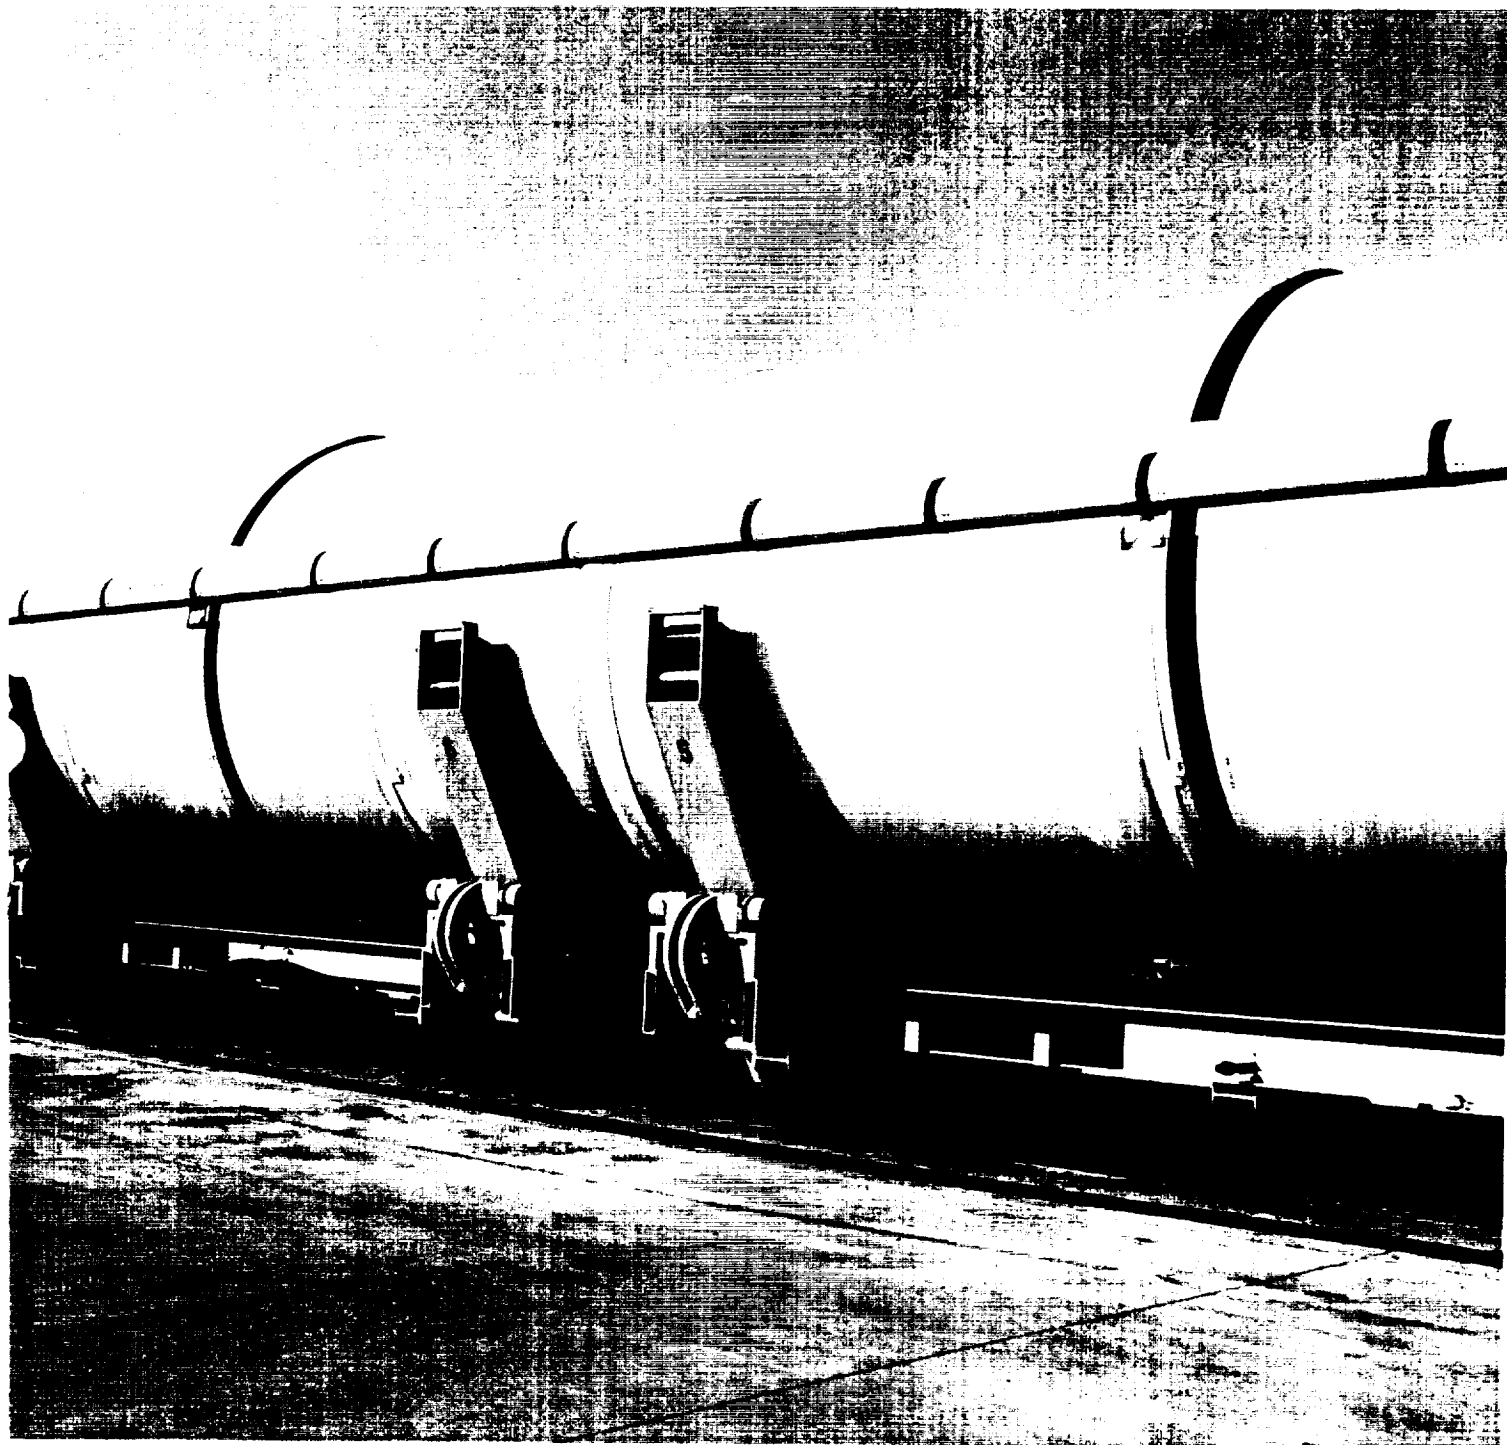
Post flight condition of the segment cases, factory joints,
and field joints was normal

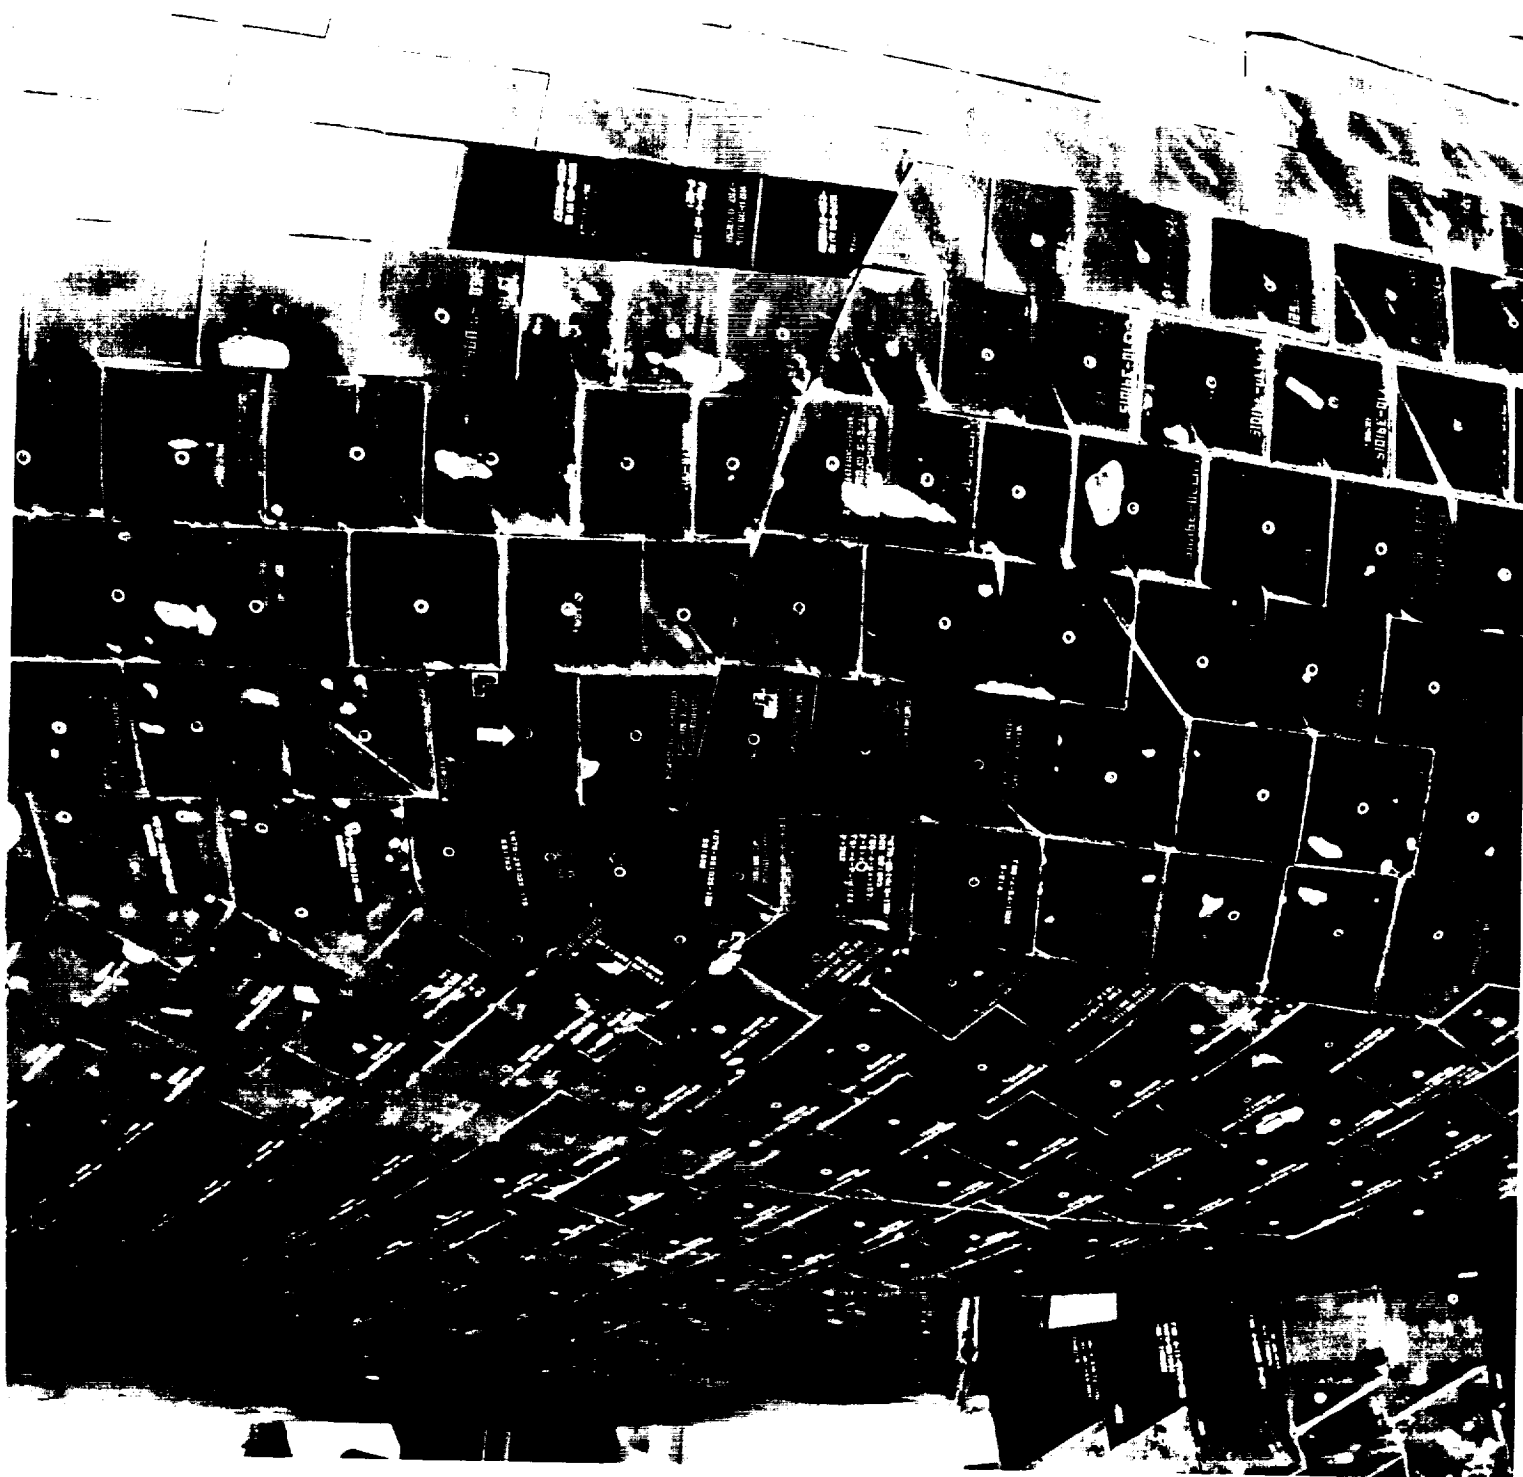
Thirty-seven hits, of which seven had a major dimension of one inch or greater, were located along the forward one-quarter of the lower right surface. Some of the hits may have been caused by ice from the ET L02 feedline upper bellows and support brackets.

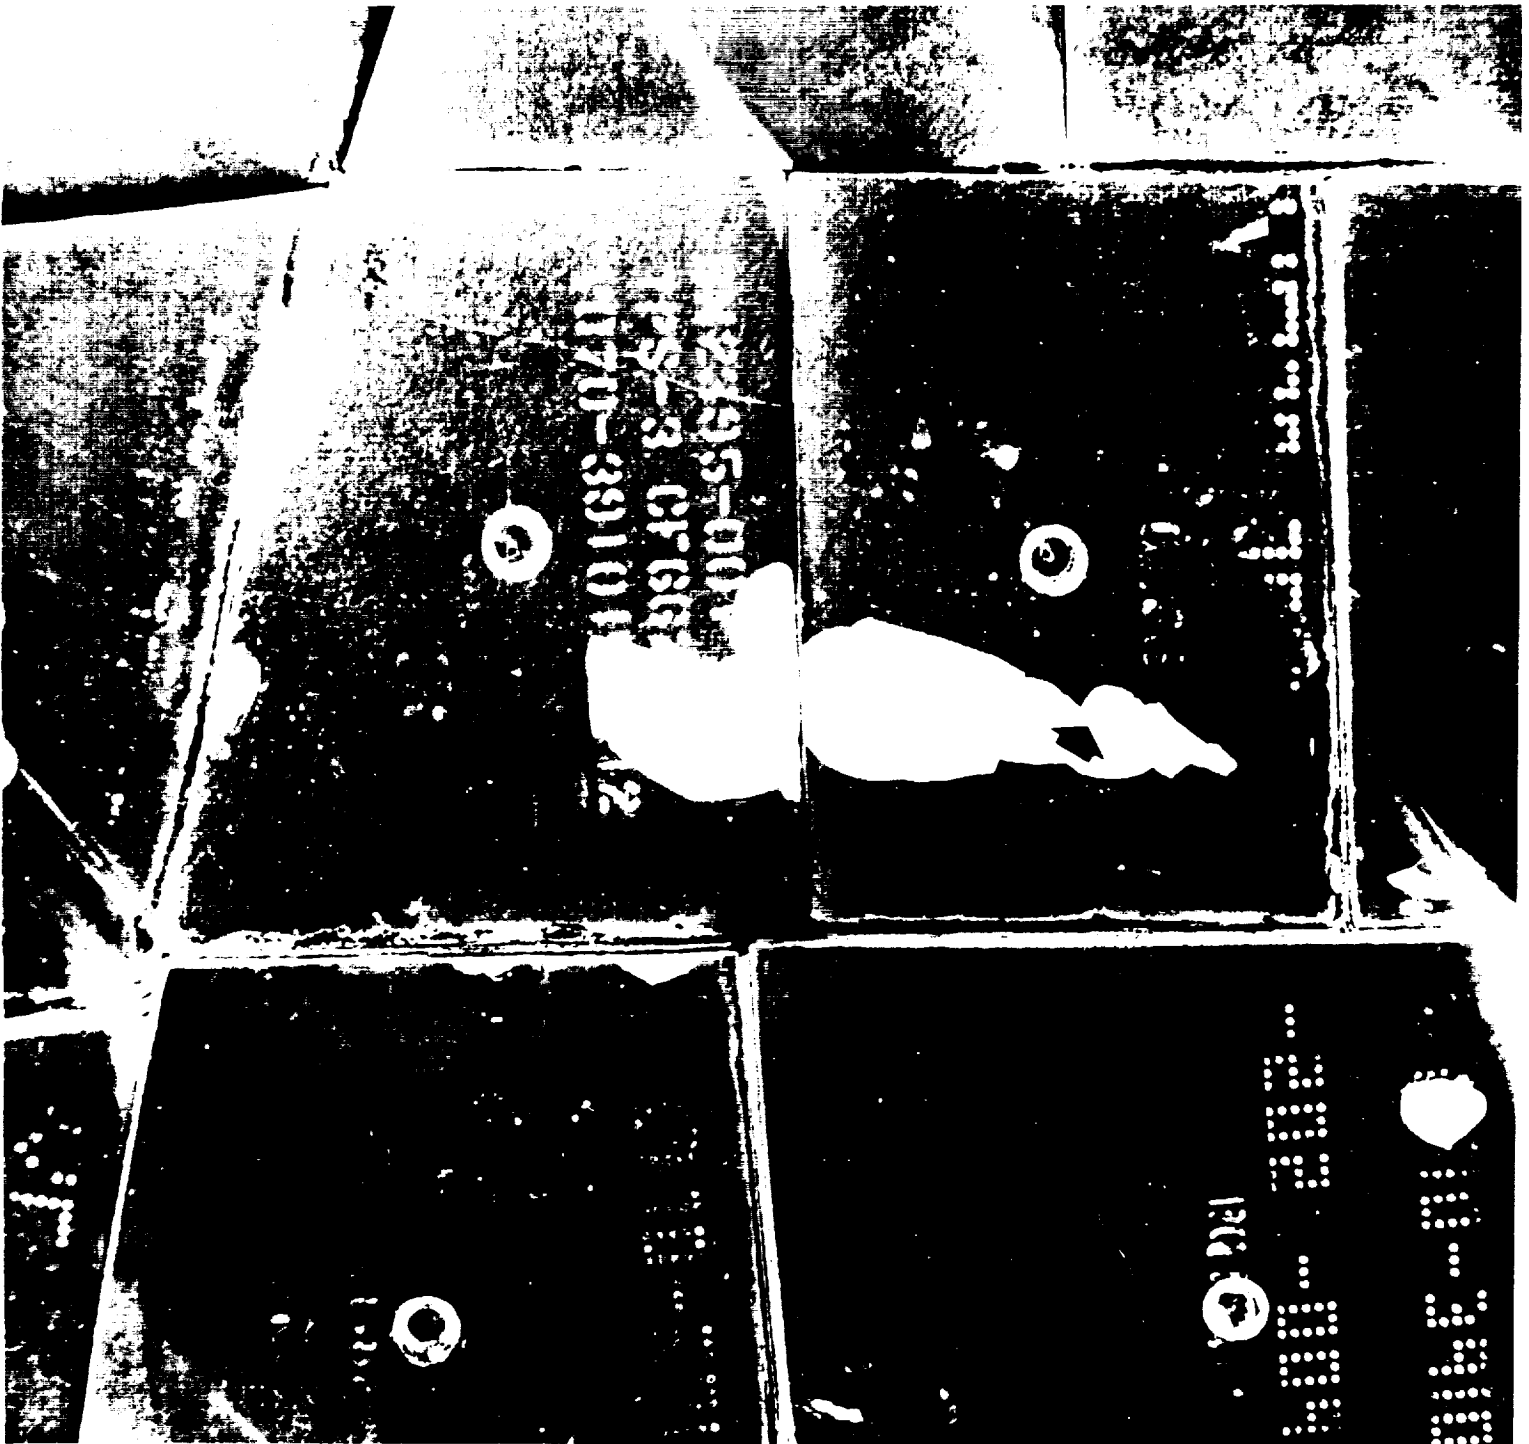
One tile damage site contained an embedded debris particle. Lab analysis showed the particle (arrow) was composed of paint and an iron-rich material of unknown origin.

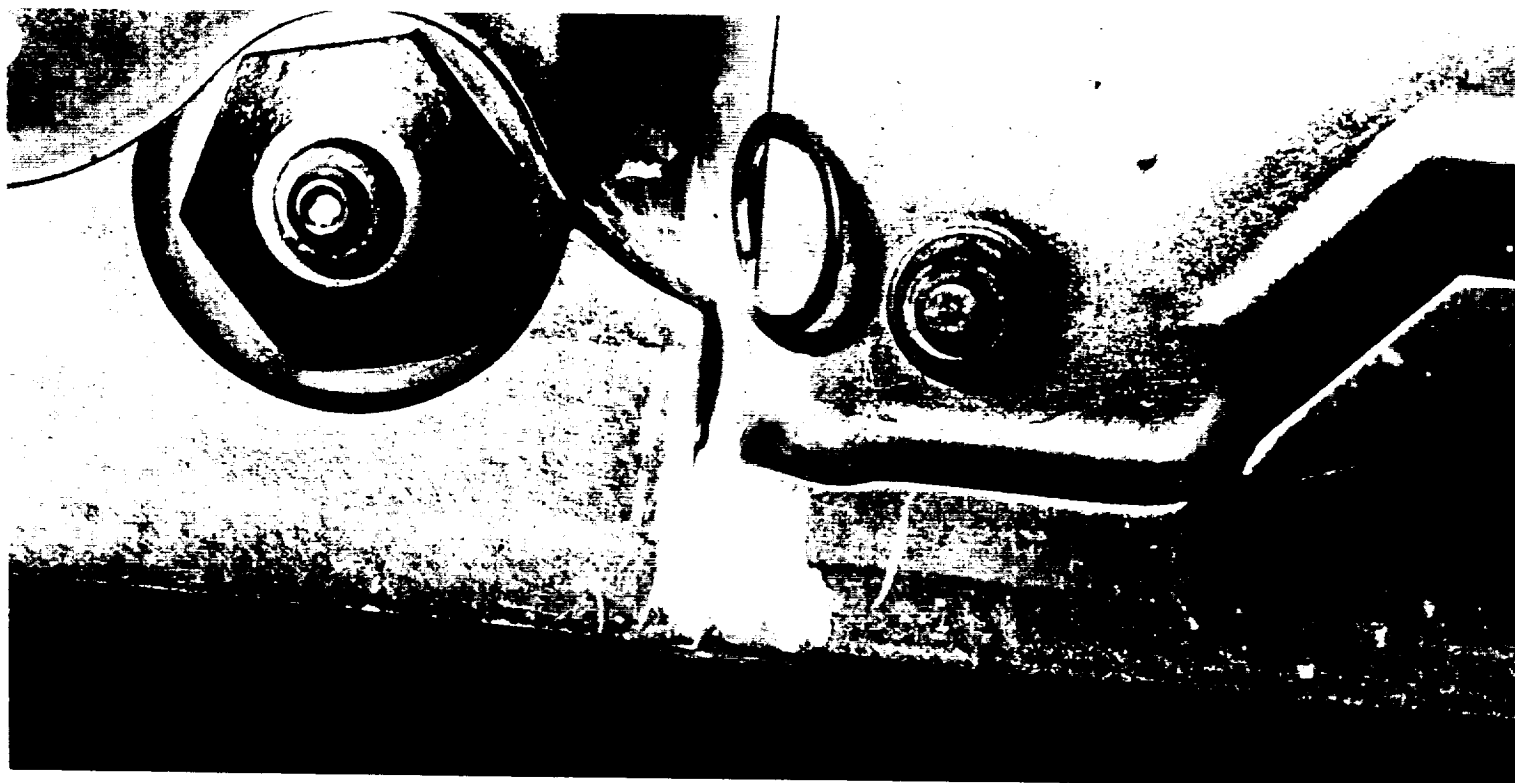
An expended NSI detonator from the aft umbilical separation system fell to the runway when the RH (LO2) ET umbilical door was opened. A coupler retaining ring from the same detonator was found adhering to some RTV on the inner surface of the door

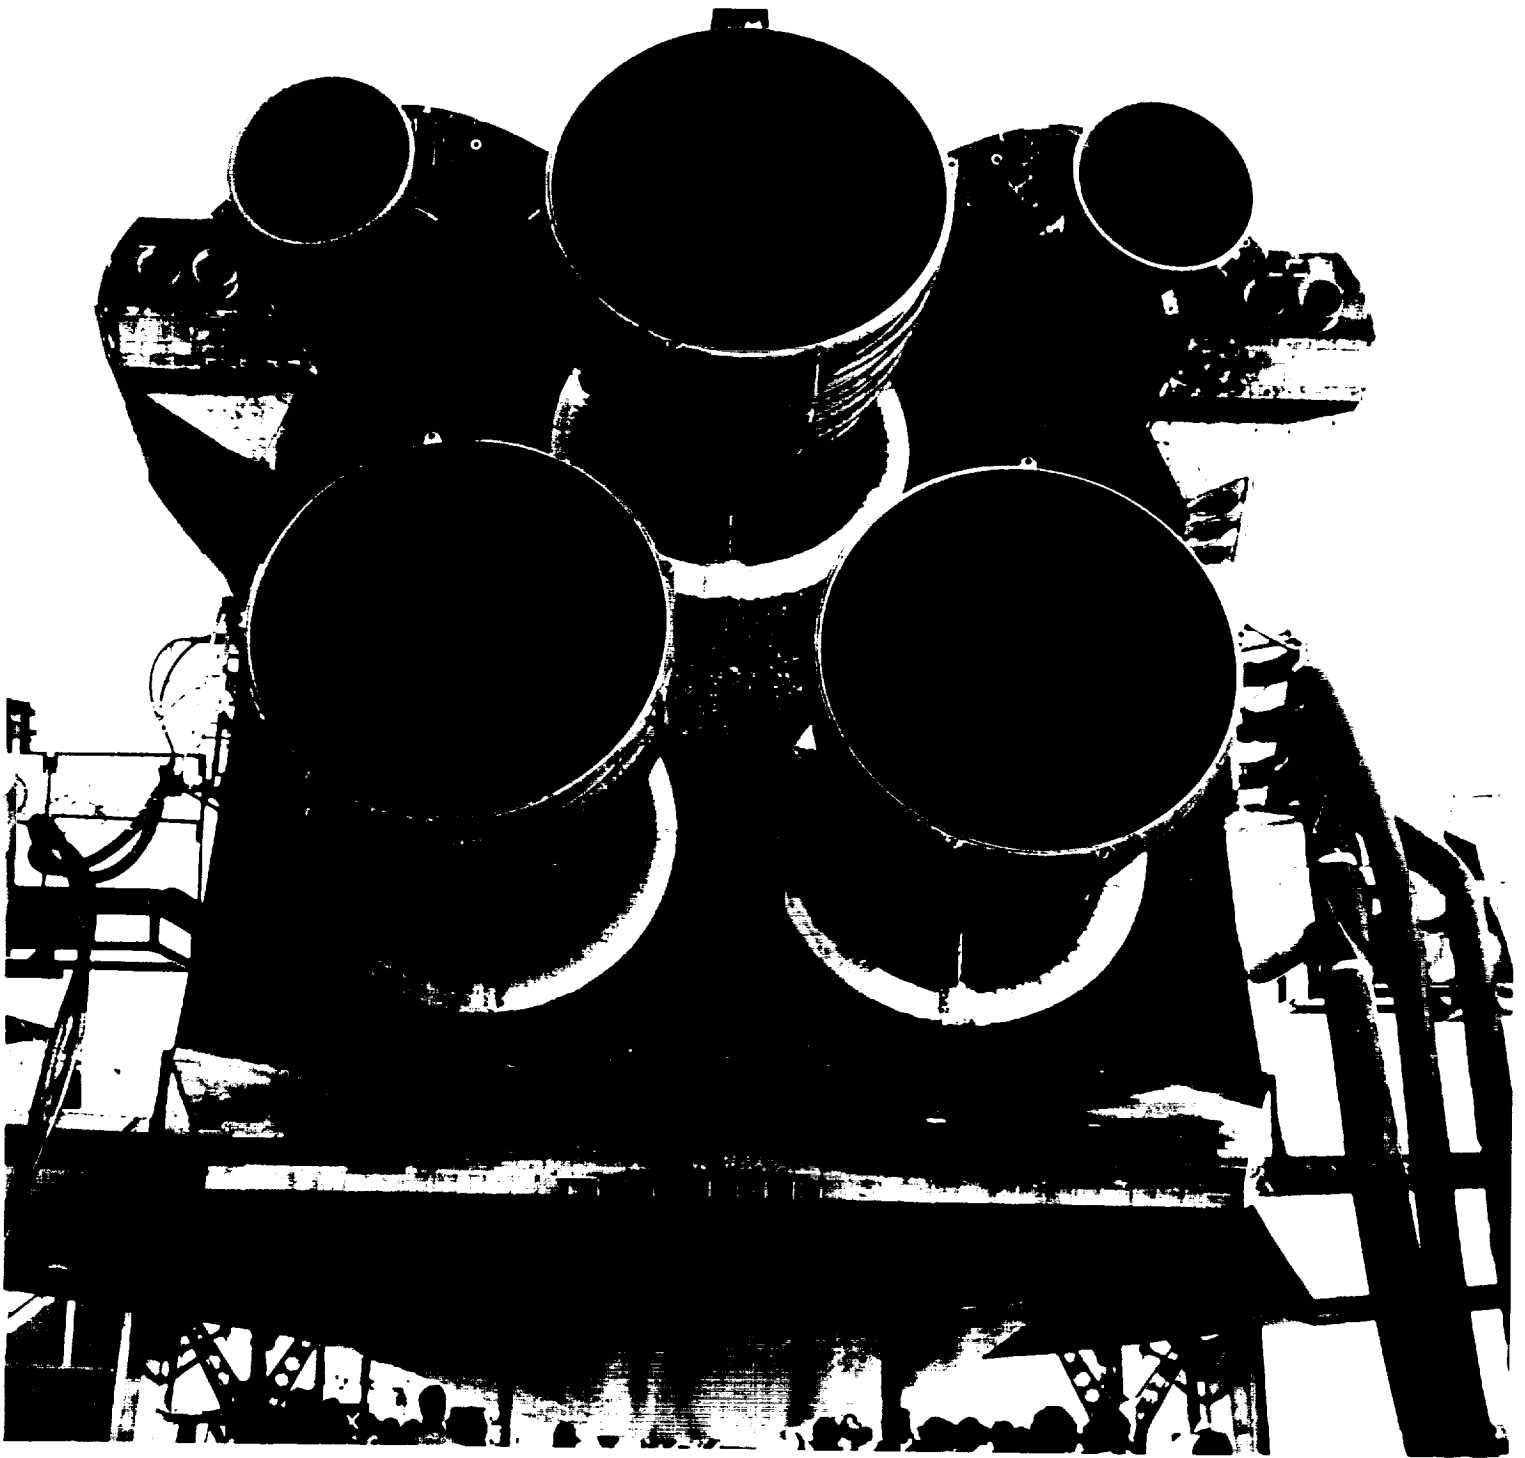
Damage to the base heat shield tiles was less than average. The closeout blanket on SSME #3 was badly torn and frayed from 7:30 to 12:00.

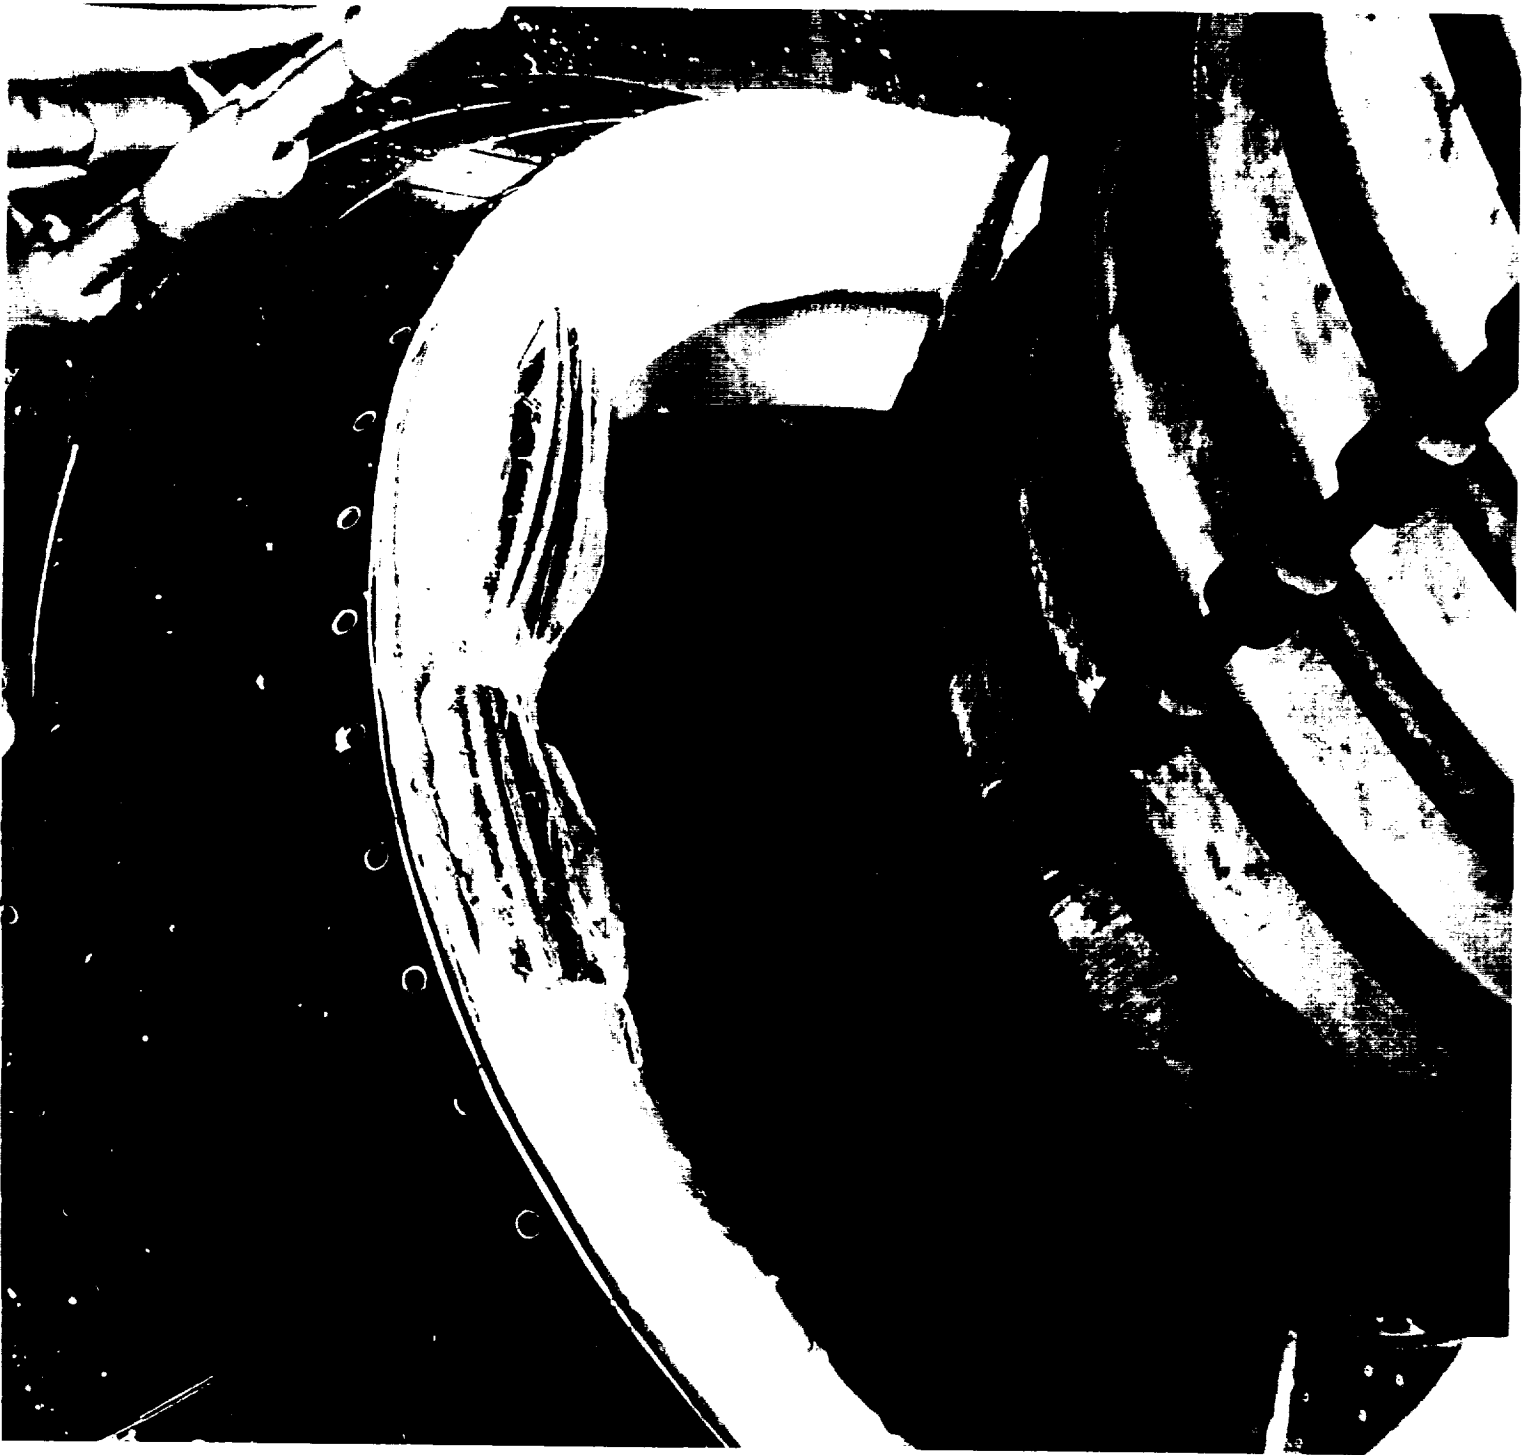
Three of the SSME Dome Mounted Heat Shield (DMHS) sacrificial patches were missing. Two of these missing patches were recovered near Pad A during the post launch debris inspection.

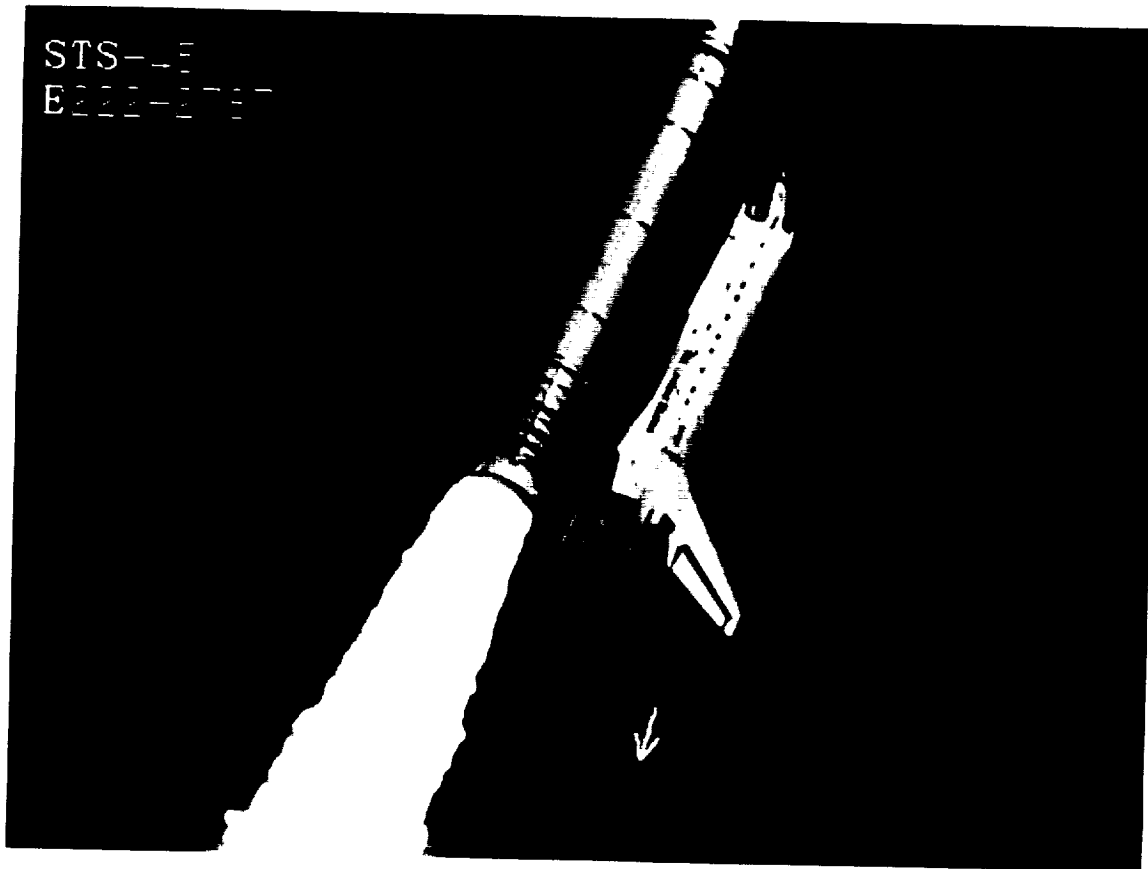
Figure 2.3.1 Flash in SSME Exhaust Plume just after Roll Maneuver

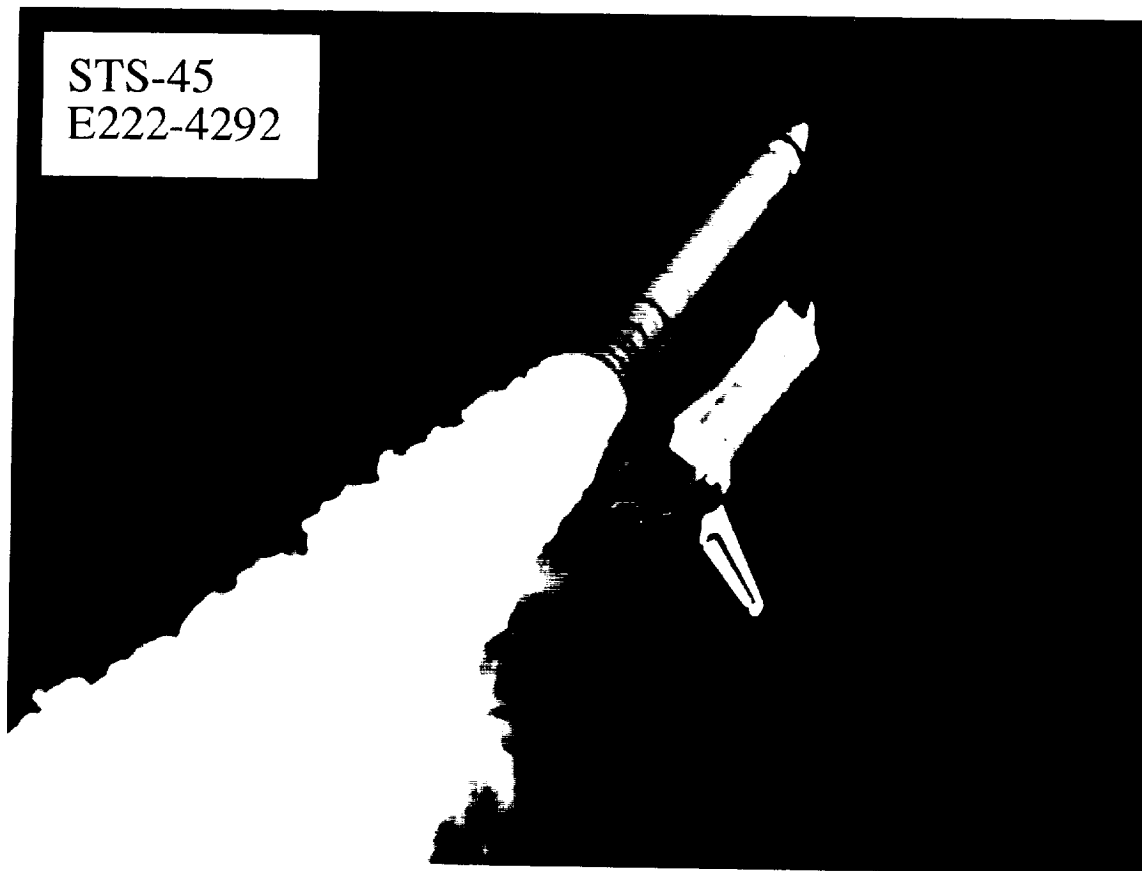
Figure 2.3.2 Flare in SSME Exhaust Plume at 38.334 seconds MET
